Vitotech Engineering, LLC

Subject: Brief Summary – *New Jersey Stray Voltage/Ground Current Investigation & Final Assessment* dated November 4, 2002

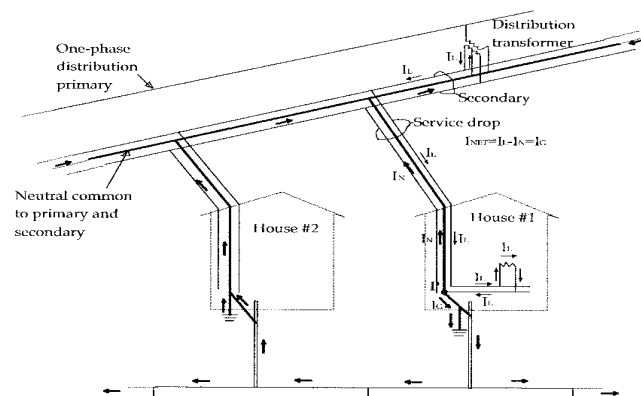
In July 2002 during the peak summer load and *exceptional drought* conditions several JCP& L customers adjacent to the Herbertsville Substation on Driscoll and Frede Drives in the Town of Brick, New Jersey, reported *tingling sensations* known as *stray voltage* while touching their pools, Jacuzzis, outdoor showers and other conductive objects. Testing revealed the problem still persisted with the main electrical panels de-energized (breakers or fuses open) indicating the stray currents (the cause of stray voltages) appeared to enter each residence from the utility pole via the overhead secondary service neutral conductor, which is bonded to the neutral-ground bus in each main electrical panel. Also grounded to the neutral-ground bus are the metallic water service pipe, ground rod, CATV and telephone drops (see diagram below for pictorial representation).

Ground Currents Caused by Residential Loads in a Typical Situation

On the utility poles the overhead secondary service neutrals are bonded to the primary neutrals, down-grounds and ground rods, CATV and telephone cable guy wires. Under normal seasonal conditions with ample rain and low soil resistivity, the primary neutral currents (known as zero-sequence currents because of the unbalanced phasing) return to the substation via the overhead primary neutral conductors and underground earth channels (composed of conductive layers of soil). Normally, earth channels return a significant portion of the primary neutral currents, which enter the underground earth channels from the pole down-ground rods, and metallic water service laterals/mains that meander under the front yards, sidewalks and streets.

The Herbertsville substation and adjacent neighborhoods “showed uniform geology in the area of concern....fine to coarse quartz sand with quartz-pebble” according to the NJGS. Since sandy soil normally has high resistivity, during the 2002 drought, the existing earth channels quickly disappeared as the water table (saturation zone) retreated forcing significantly more primary neutral current to return to the substation via the overhead primary neutrals. This additional primary return current increased the voltage potential (difference) between the substation ground (now electrically isolated from the adjacent neighborhoods due to the exceptional drought and sandy conditions) and the multi-grounded primary neutral (MGN) distribution systems in the adjacent neighborhoods. The consequence was an increase in neutral-to-earth voltages (NEV) on the pole down-grounds and grounded-neutrals in the main electrical panels within homes near and adjacent to the Herbertsville substation.

1. Oversize primary neutrals on Lines 80, 81, 82 and 83 as specified in *Figure #12, Recommended Upgrade To Primary Neutrals* to match the size and impedance of the 397AA phase conductors. A total of 37,600 feet (7.12 miles) of upgraded 397AA primary neutrals are recommended to mitigate the stray voltage problem and achieve a neutral-to-earth voltage of 4-5 volts during summer months on the substation grid and down-grounds of the adjacent neighborhoods during peak summer loads. Specific routes and circuit length details for the recommended upgraded primary neutrals are provided in Figure #12; however, selected lateral circuits may also require upgraded 397AA neutrals to achieve the 4-5 volt summer performance objective including: Azalea Drive, Truman Drive, Harding Drive, Roosevelt Drive and Old Squan Drive.

3. Balance the phases on Lines 80, 81, 82 and 83 to within 10% (as measured by the SCADA equipment at the substation) during average loads (20-25%) and no more than 15% during peak summer loads to minimize zero-sequence currents.
